Name Of Dam: **CAMP HYDAWAY**  
Location: **CAMPBELL COUNTY**  
Inventory Number: **VA. 03113**

## PHASE I INSPECTION REPORT NATIONAL DAM SAFETY PROGRAM

APRIL 1981

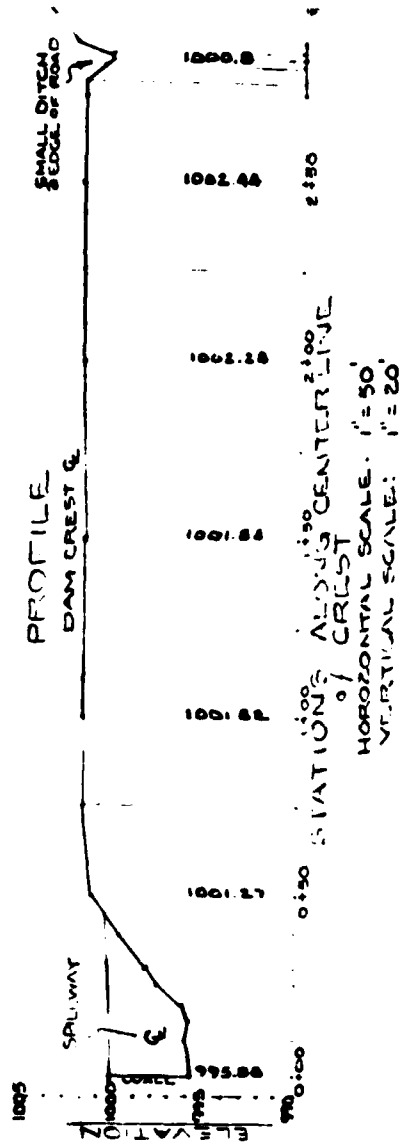
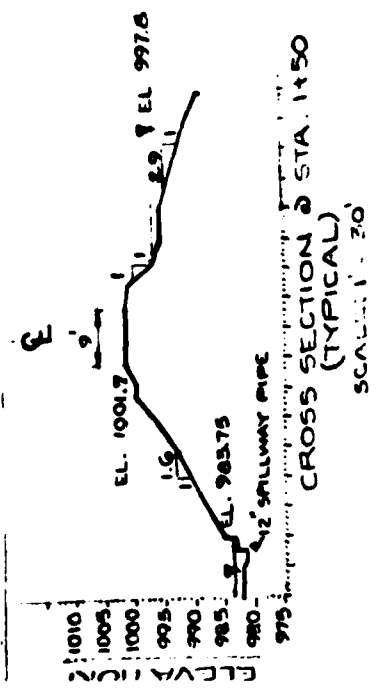
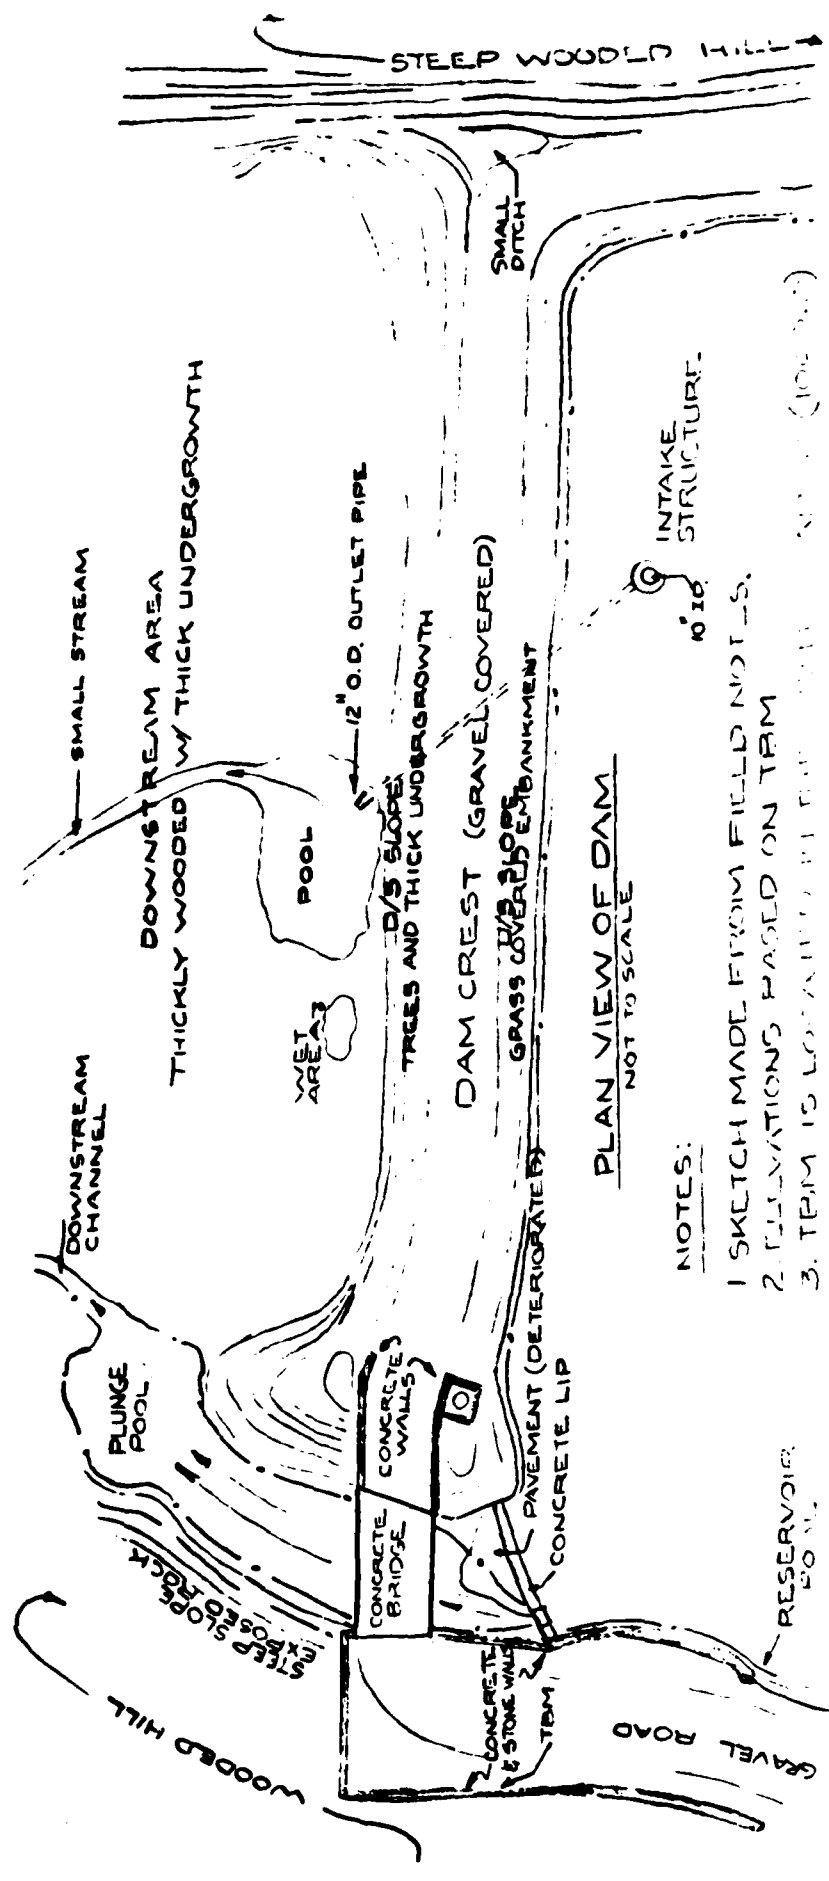
CAMP HYDRAWAY DAM  
2 APRIL 1981  
11:45 AM

3.1.2 Embankment: A sketch of the embankment showing a cross section and crest profile is provided in Appendix I. A plan view is also given in Appendix I.
